# Manhole Inspection Summary

Manhole # S13GG2006MH

**Location** Address: **6100 WESTCLIFF DR**

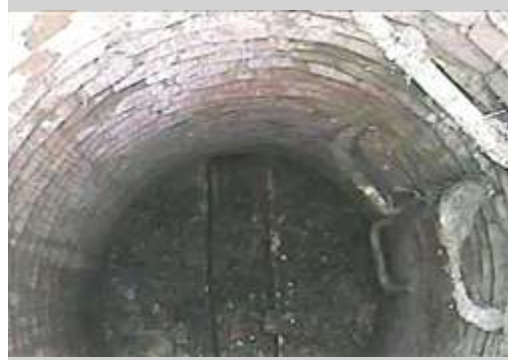
Top View

Evidence of surcharge - Bench debris.  
Channel debris.

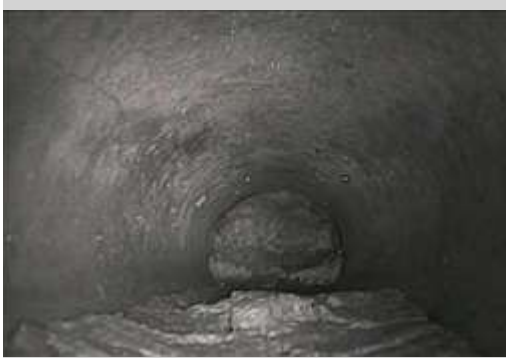
Inside the I6

Clogged or Capped.

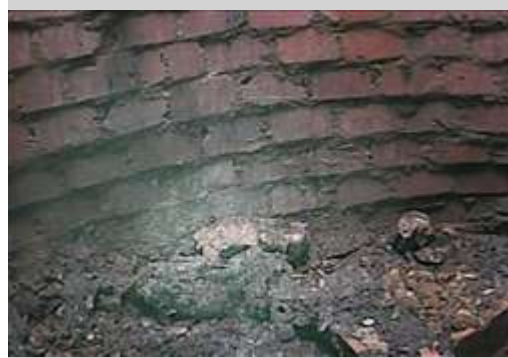
Defect

Condition: ☐ Sound ☐ Cracked ☐ Root Intrusion ☐ Loose Brick ☒ **Deteriorated**

Infiltration: ☐ None ☐ Joint ☐ Cracks ☒ **Mortar** ☐ Roots ☐ Wall

Barrel deterioration and infiltration.  
Bench debris.

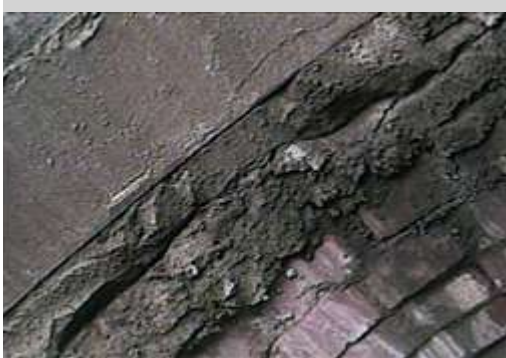
Defect

☒ **Leaks**

Condition: ☐ Sound ☐ Cracked ☐ Root Intrusion ☐ Loose Brick ☒ **Deteriorated**

Infiltration: ☐ None ☒ **Joint** ☐ Cracks ☒ **Mortar** ☐ Roots ☐ Wall

Frame leaks. Adjustment deterioration  
and infiltration.

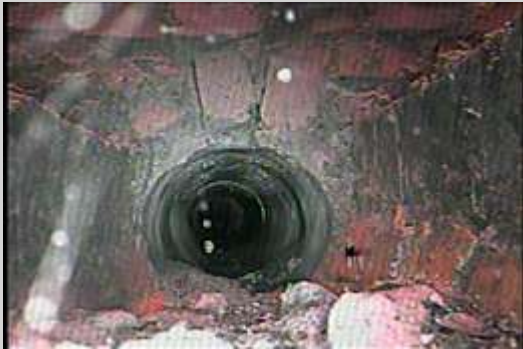
### 8 in. Circular Gravity Sewer Pipe Out @ 12 O'Clock

Channel root intrusion.

Deposits: ☐ None ☒ **Mud** ☐ Sludge ☒ **Debris** ☐ Grease

Infiltration: **Evidence** Pipe Seal Cond: **Cracked**

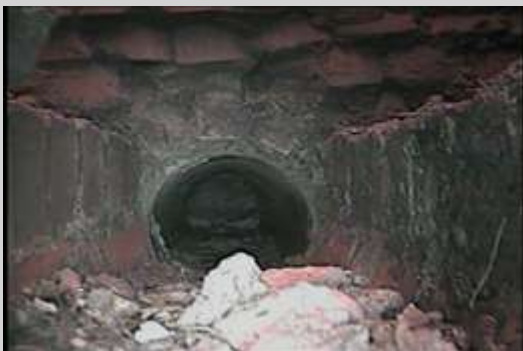
### 8 in. Circular Gravity Sewer Pipe In @ 6 O'Clock

Deposits: ☐ None ☐ Mud ☐ Sludge ☒ **Debris** ☐ Grease

Infiltration: **Evidence** Pipe Seal Cond: **Cracked**

Connects To: **Stub connection / abandoned**
